THE ANALYSIS OF ENGINEERING PROPERTIES OF SOILS FACILITATING THE MECHANISM OF LANDSLIDES IN HAKHA AREA, CHIN STATE, MYANMAR

Abstract

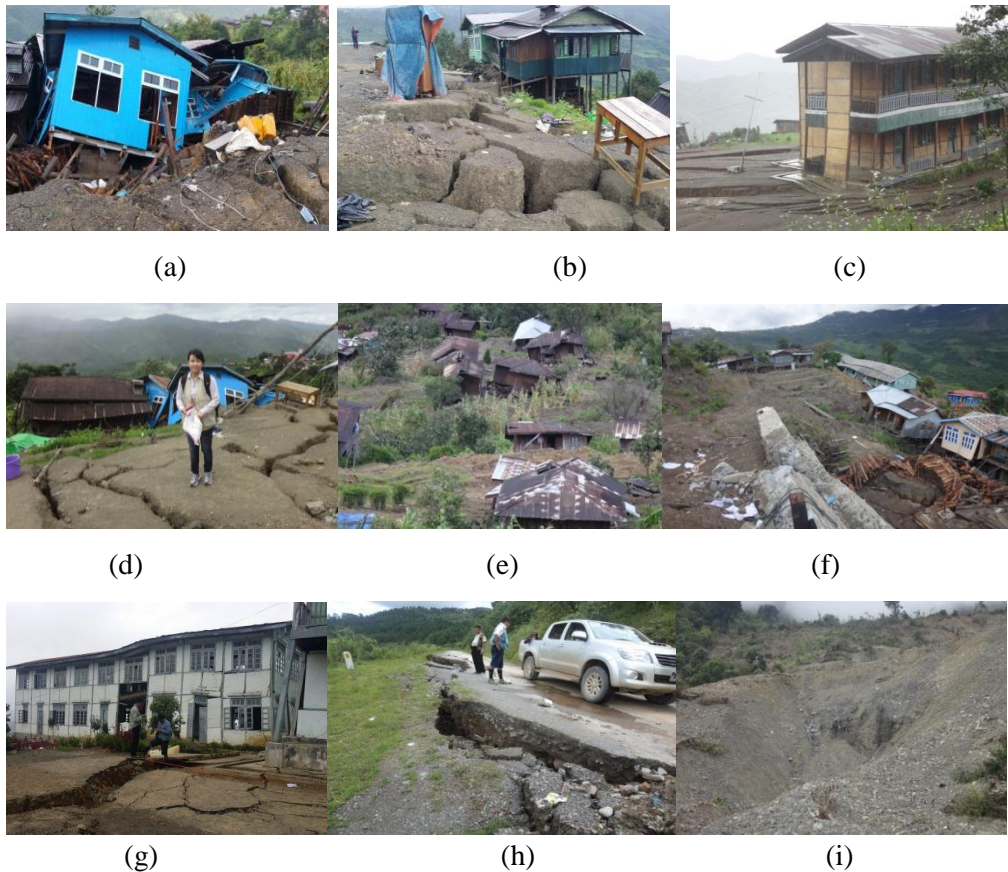
Figure 4: The destructions of houses school and houses in Myohaung quarter (a to i)

numbers of bulidings/houses, schools, retaining walls and numerous cracks almost all over the road were recorded and shown in figures 4 (a-i). Among those landslides, some failures showed that the slides happened again on former landslide materials. The types of landslides are based on inclination of slope, heterogeneity, weathering grade, bedding nature and types of lithology. Three types of landslides are classified in the study area according to the classification of Varnes 1978 .

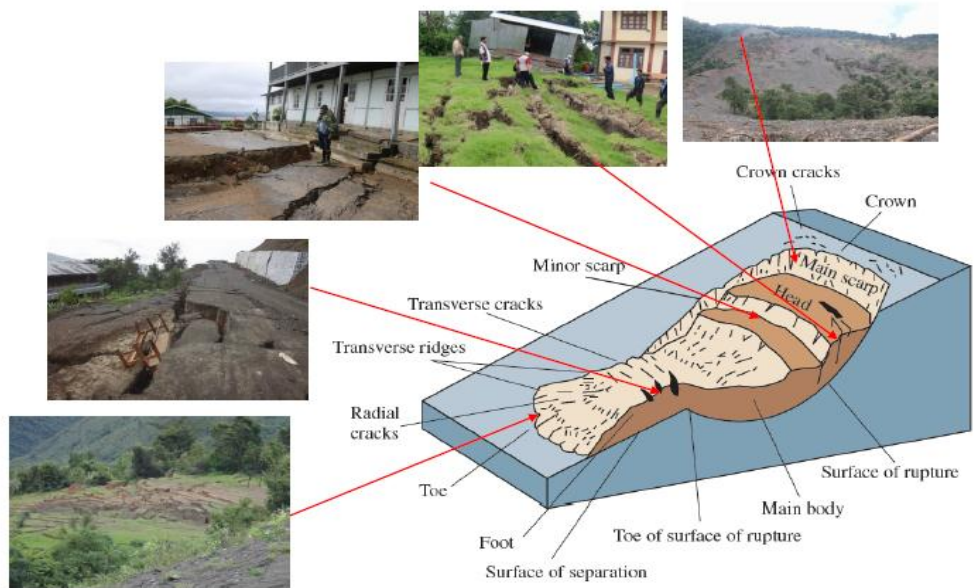
Figure 5: Reactivated deep seated rotational slide of Mt. Rung

The most common destructive type is deep seated rotational slide, the second is flow type and the third is translational type or plane failure. Among them, Mt.Rung is the biggest and it is reactivated on ancient giant old landslide which can be inferred from the Landsat images.

The landslide crown can be sharply observed on the top of the Mt. Rung which is about 500m wide. Before this event, the lake was situated in the middle of this slope and currently there was no trace of it and left only the landslide materials. On the slope face, the small seepages from indurated shale layer were observed which is one of the critical factors to cause this failure. The landslide materials in Mt. Rung slope are composed of colluvial soils consist of various sizes of sandstone and mudstone fragments such as 3cm to 6cm and some consist of 30 cm to boulder size sandstone. Under this colluvial soil, very thin bedded, very fissile indurated shale from which the groundwater seepages are common and thick bedded sandstone are interbedded. Those medium to thick sandstone beds are well exposed on the top of the Mt. Rung, dipping the same direction of the landslide direction and this is also one of the critical factors to failure. Another factor is the heterogeneity and unconsolidated condition of colluvial soils which appeals the infiltration of water that increase the pore pressure together with decrease of effective stress based on the intensity and duration of rainfall, permeable and less impermeable characteristics of the layers of the slope.

Based on thorough field investigation, the ancient landslide scars on top of the Mt. Rung from Landsat images and relation to landslide materials and failure conditions, all those cracks and failures are interconnected on this slope. As a result, the length of the Mt. Rung slide is about 1000m to the bottom. Therefore, this can be concluded that this Mt. Rung landslide is reactivated deep seated rotational slide as shown in figure (5).

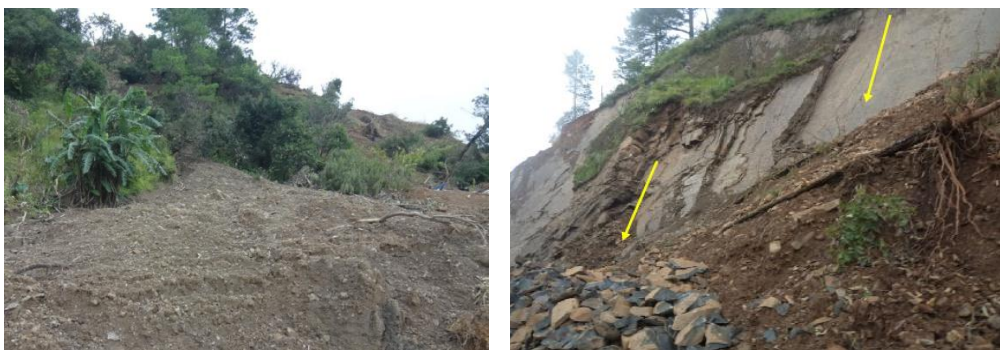
Figure 6: Flow type failure in (a) and Plane failure in (b)

The flow type of failure can be clearly observed at 2/2 mile post of Hakha-Gantgaw Road. They can be usually observed on very steep slope with narrow valley composed of highly jointed rock or soil. The rain water shall be trapped temporarily due to collapse of soil from valley side and abruptly flow down with very high speed after intense rainfall. Another huge landslide was recorded beside this and two fish farms near the base of the slope covered with those landslide deposits.

The translational slide or plane failures are very common along the high way road. The slope cutting and bedding direction are in the same direction and this has the effect of causing the plane failure. The typical plane failure at 3/3 mile post of Hakha-Matupi road is shown in figure (6).

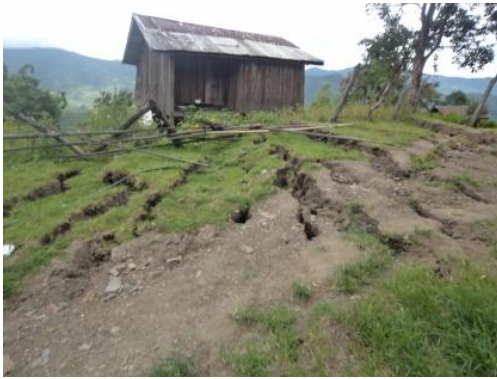
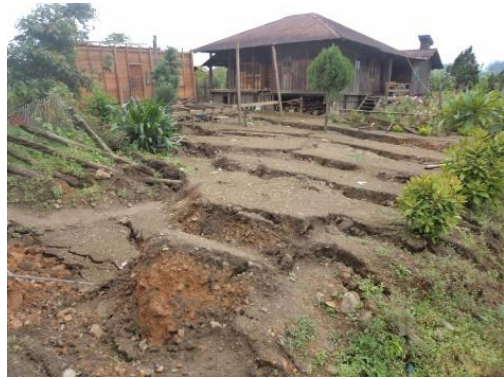
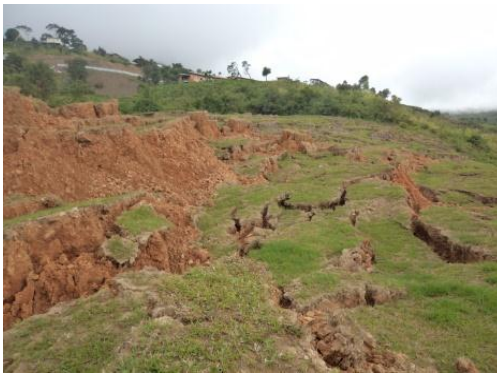
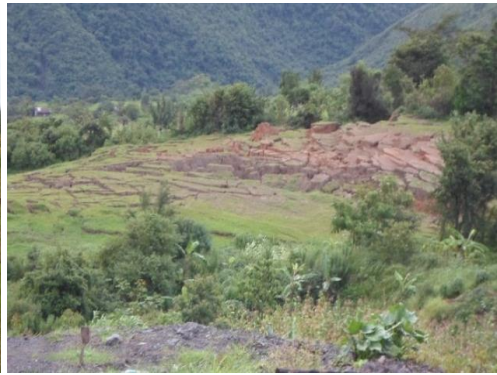
Figure 7: The nature of forcibly break down of cracks on the slope (a-e)

During field investigation, the numerous cracks are observed on the slopes. There were traces of forcibly break out natures on the soil surfaces among the cracks. Those natures in landslide of Hakha area are not quite common as usual tension cracks of landslide in other places. The uplifting of some soil blocks among the cracks are noticeably seen in figure (7). This fact needs to be explained by the determination of dispersive test.

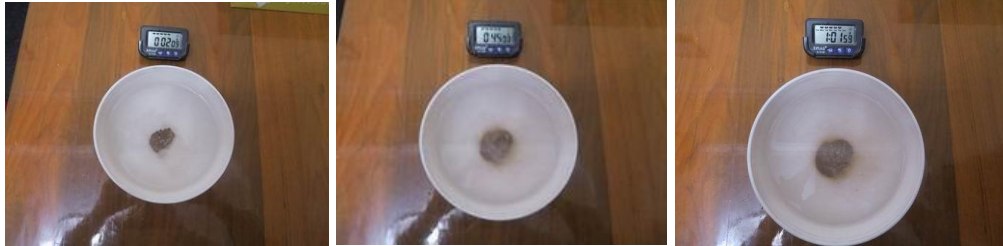
Figure 8: Dispersive test on the sample (depth- 4ft) from Sangling Church, Hakha, GPS Point: (0563476 E, 2504958 N)

Result: Grade3(Moderate reaction)

The samples shows Grade 3 (moderate reaction) to Grade 4 (severe condition) as shown in figure (8-10). From the dispersive test, the formation of cracks are due to high content of sodium content in soil when they in contact with rainwater and forcibly break down.

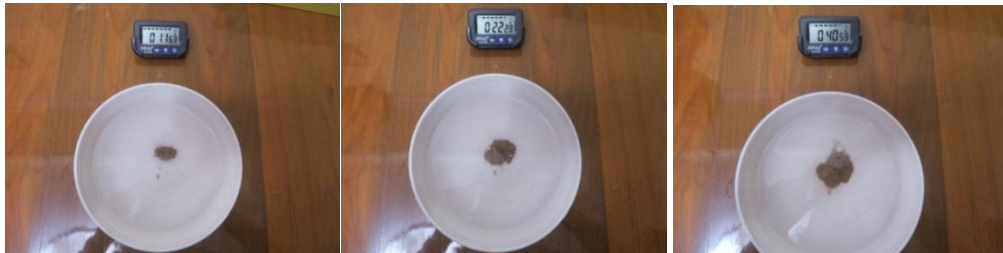
Figure 9: Dispersive test on the sample (depth- 12ft) from Sangling Church, Hakha GPS Point: (0563476 E, 2504958 N)

Result: Grade3(Moderate reaction)

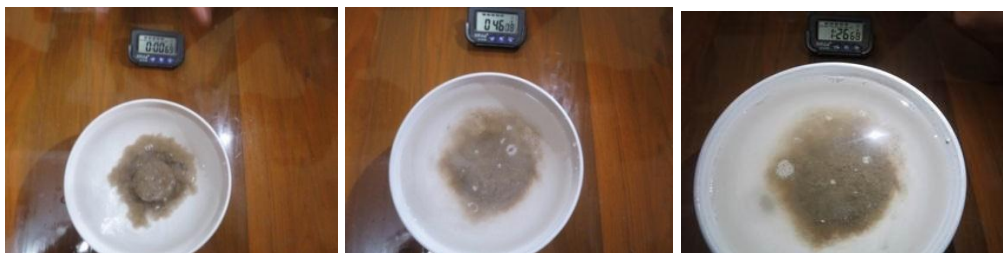
Figure 10: Dispersive test on the sample from the lobe Surface of Chunsung Mudstone (Indurated Shale) GPS Point: 0560517E, 2506832N

Grade 4: Severe reaction

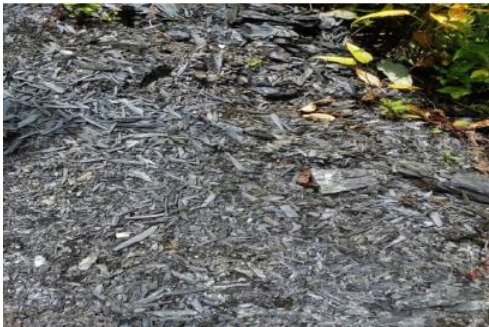
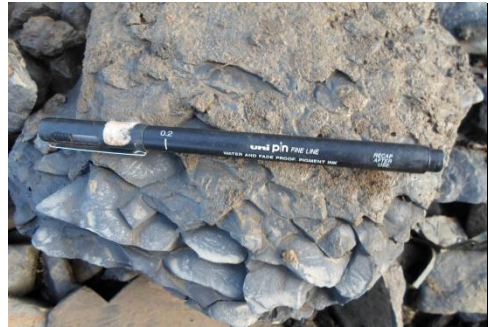
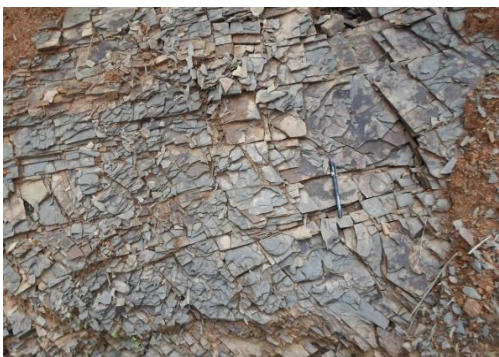
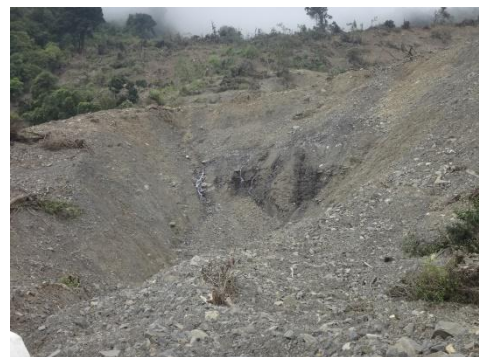
Figure 11: The dispersive nature of rock fragment (indurated shale) from Chunsung Formation

The soils are derived from the weathering of parent materials of chunsung mudstone Formation. Not only the soil but also the weathering nature of indurated shale shows the numerous cracks and small pieces of rock fragments as shown in figure (11). On landslide surface, the black colour small pieces of rock flour from which the water seep out as in figure (11- d) can be observed. Those rock flour samples were collected for dispersive test and the result show Grade IV severe reaction when in contact with distilled water.
