AN ENVIRONMENTAL APPROACH: IMPACT OF CHANNEL BANK CHANGE OF SITTAUNG RIVER IN KAWA TOWNSHIP

San San Khine¹, Nyunt Nyunt Than² and Zaw Zaw³

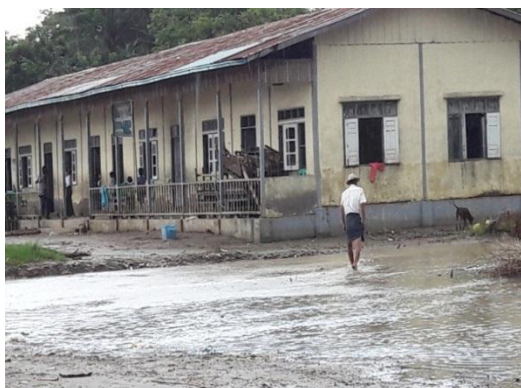
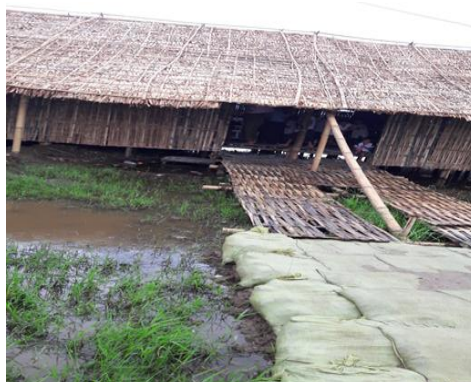
Plate -7 State Primary School Building in Main Mamauk Village (22.6.2017)

Plate -8 State High School Building in Mamauk- Ywa Thit After Moving on (22.6.2017)

Plate-7 and 8 show that school buildings' condition within main Mamauk and newly located Mamauk. The major State primary school of main Mamauk is located not far from the site eroded by the Sittaung river and is facing the problem of flooding during rainy season. Therefore, this school is likely to be moved to new Mamauk village. The major education problem of Mamauk village is insufficient number of teachers and school infrastructures.
