SOIL DEGRADATION ALONG YANGON-NAYPYIDAW HIGHWAY BETWEEN MILE POST 10 AND 40 IN MYANMAR

Abstract

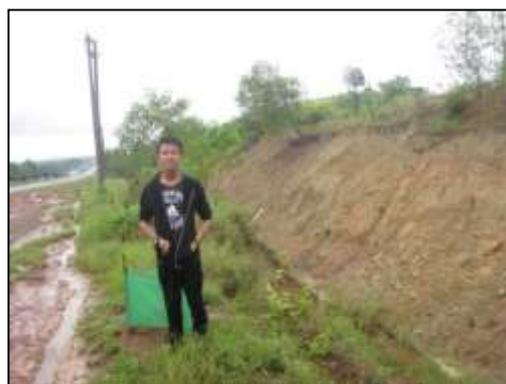
Figure 2 Residual soil outcrop of Older Alluvium at mile post 15/4

The study area is generally composed of Neogene clastic sedimentary rocks of Kyaukkok Formation (Early Miocene) and Obogon Formation (Middle Miocene), Irrawaddy Formation (Late Miocene to Pliocene), Older Alluvium (Pleistocene) and Younger Alluvium (Holocene). The study area along highway is mainly covered by Irrawaddy Formation, Older Alluvium and Younger Alluvium. Older Alluvium is composed of lateritic soil, silty sand and sandy silt mainly exposed along the road (Figure 2). Younger Alluvium is found as farms and stream sediments which is mainly composed of clayey silt and silty sand. The regional geology of the study area is described in Figure (3).

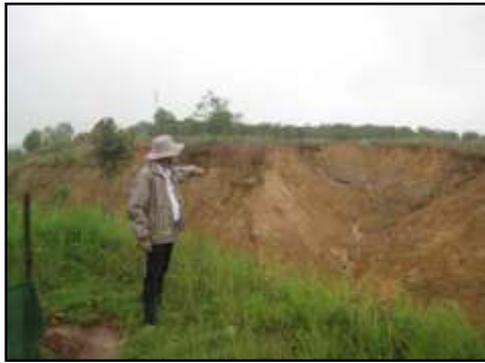
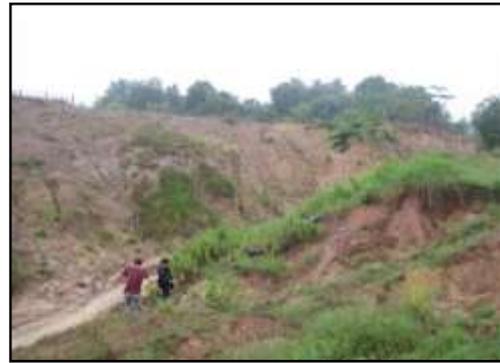
Figure 7 (A) Nature of gully erosion at Gully A (B) Recently eroded nature at Gully B

Table 1 Field measurements of gully erosion at location 1

Loc. 1	Width (b)	Length (l)	Depth (h)	Slope of gully (s)	Eroded area	Estimate volume	Gully Material
Gully A	7 m	60 m	5 m	6.5 m	1235 m ²	1050 m ³	Silty Sand
Gully B	12 m	70 m	7 m	9 m	2184 m ²	2940 m ³	Silty Sand

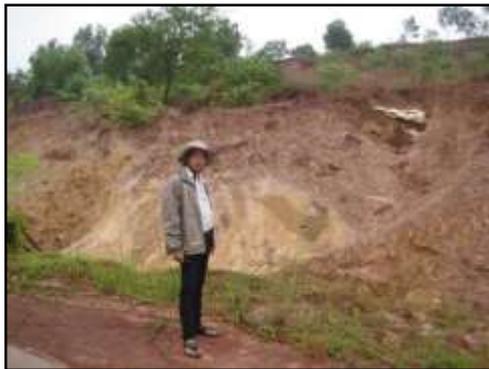
Figure 8 Nature of gully erosion at Location 2

Table 2 Field measurements of gully erosion at location 2

Loc. 2	Width (b)	Length (l)	Depth (h)	Slope of gully (s)	Eroded area	Estimate volume	Gully Material
Gully A	3 m	70 m	3 m	4 m	779 m ²	315 m ³	Sandy Silt

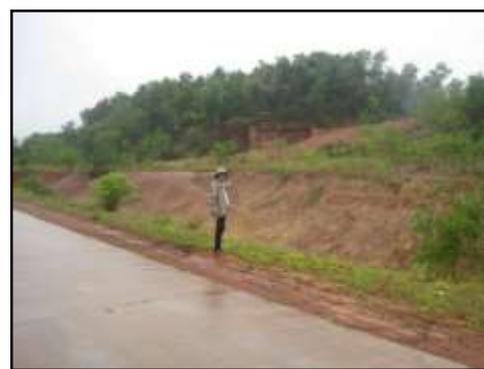
Figure 9 Gully erosion caused by heavy rainfall at Location 3

Table 3 Field measurements of gully erosion at location 3

Loc. 3	Width (b)	Length (l)	Depth (h)	Slope of gully (s)	Eroded area	Estimate volume	Gully Material
Gully A	15 m	75 m	6 m	7.5 m	2340 m ²	2275 m ³	Sandy Silt

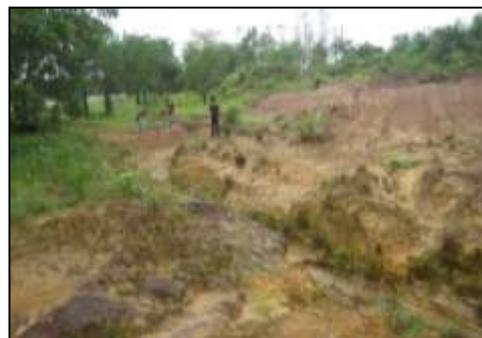
Figure 10 Gully erosion caused by heavy rainfall at Location 4

Table 4 Field measurements of gully erosion at location 4

Loc. 4	Width (b)	Length (l)	Depth (h)	Slope of gully (s)	Eroded area	Estimate volume	Gully Material
Gully A	4 m	45 m	4 m	4.7 m	619 m ²	360 m ³	Clayey Silt
