## **A STUDY ON LANDSLIDE POTENTIALS AND SLOPE STABILITY OF THE ROAD AT ZWEKABIN RANGE NEAR KHALAUKNOS VILLAGE, HPA-AN TOWNSHIP**

The research aims to mention the landslide hazard and mitigation measures in the Zwegabin Range. This study road is located at the eastern part of the Zwegabin Range near Khalauknos Village, Hpa-an Township, Kayin State. This area is mainly composed of cherty limestone and lime-mudstone of Moulmein Limestone (Permian in age). Moreover, the area lies in the Zwegabin-Belin Fault Zone, a right-lateral strike-slip fault. Hilly terrain with steep slopes is found in the most of places at the study route and structurally unstable. The big landslide occurred on 15<sup>th</sup>, July in 2018 on the road at Zwegabin Range. Rock mass characterization and slope stability analysis are carried out for potential of landslides in the research area to know causes of landslides and preventing systems. In the study, although the behaviors of the rocks are not quite different along the road, the strength and engineering properties of the rocks are varied from place to place. Plane failures and wedge failures commonly occur. Most of the slopes are dangerous attaining stabil

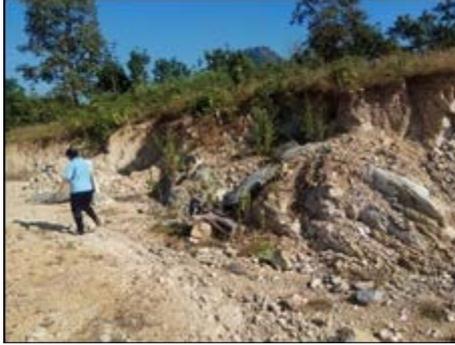
**Figure 5** Thin bedded, whitish grey to pinkish colored siltstone intercalated with thinnly laminated shale, partly fine grained nodular sandstone of Taungnyo Formation at the northern part of Zwegabin Range

The rocks of the Taungnyo Formation are exposed at the northern part of the Zweekabin Range and southern part of the Hpa-an Town. The rocks are mainly composed of clastic units; thin bedded, whitish grey to pinkish colored siltstone intercalated with thinly laminated shale, partly fine grained nodular sandstone which is shown in Figure (5).

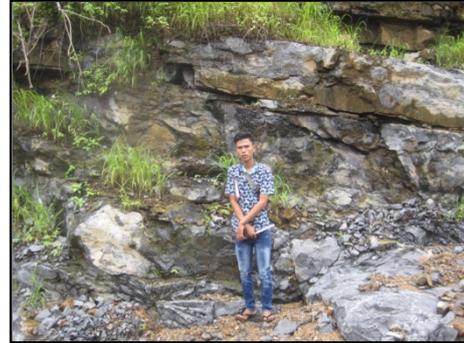
**Figure 6** Medium to thick bedded, grey to dark grey colored lime-mudstone of the Moulmein Limestone exposed at the west of Naunglon (East) Village

Moulmein Limestone is mostly composed at the Zweekabin Range with gentle dipping. The other isolated hills with karst topography are also composed of Moulmein Limestone. The rocks are consist of medium to thick bedded, grey to dark grey colored lime-mudstone and brecciated limestone of the Moulmein Limestone (Figures 6-8).

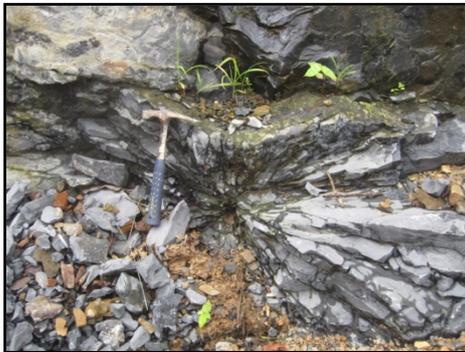
**Figure 7** High pressure radial joint pattern in lime-mudstone with chert nodule at the Naunglon (east) village

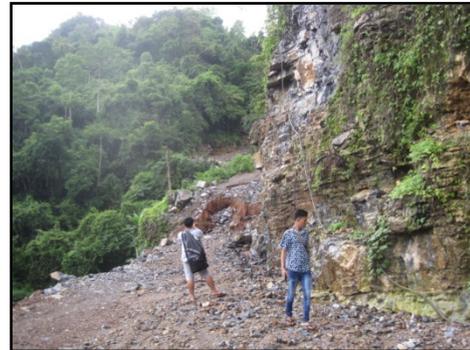
**Figure 8** Intersection of two normal faults with vertical striation (N16° 57' 00.2", E97°25'51.0", Facing - 260°)

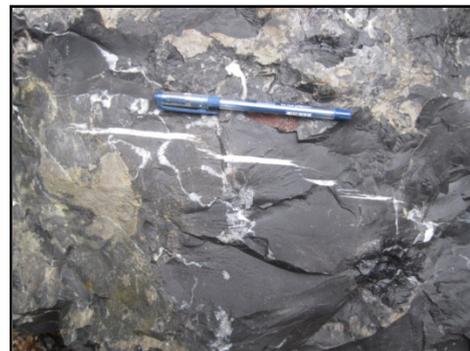
**Figure 10** Extensional normal fault planes cutting in calcite vein at the west of Naunglon (East) Village

nearly north-south in direction (Figure 9 & Figure 10). Another thrust fault is also trending parallel with the above normal fault (Figure. 11). Besides, the Zwegabin (east) Fault is trending nearly NW-SE direction at the east part of the Zwegabin range which occurred as the right-lateral strike-slip faults (Figure 12). Moreover, the anticlinal fold is occurred with NNW-SSE trending at the western part of the Zwegabin Range.

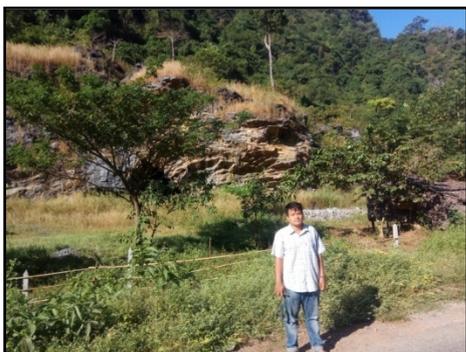
**Figure 11** Thrust sheet at the west of the Zwegabin Range

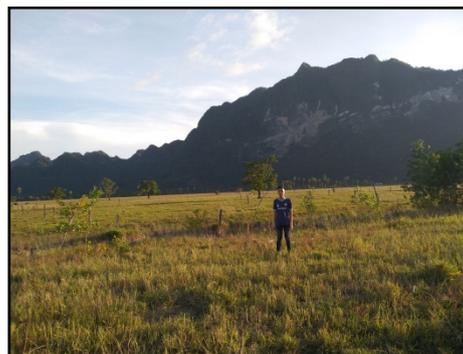
**Figure 12** Strike-slip fault at the east side of the Zwegabin Range

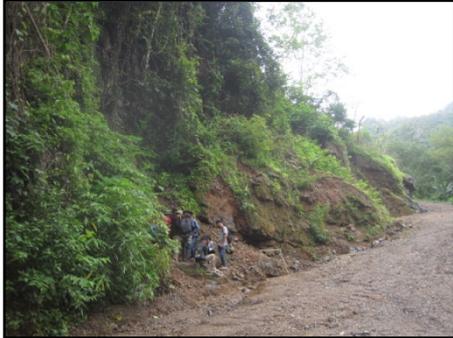
**Figure 14** Rockfall in lime-mudstone of Moulmein Limestone (N16°49'13.1, "E97° 41'11.4", Facing - 170°)

effect. Most of the slope failures are formed by the following effects; (a) uncontrolled cutting the slope, (b) coincide with fault line (c) highly rainfall effect and (d) weathering effect. According to the Varnes (1978), there are many types of landslide along the car-road such as rockfall (Figures 14 & 16), debris flow (Figure 17, 18, 19 and 20), creep (15) and size of the landslide is shown in Figure (21).

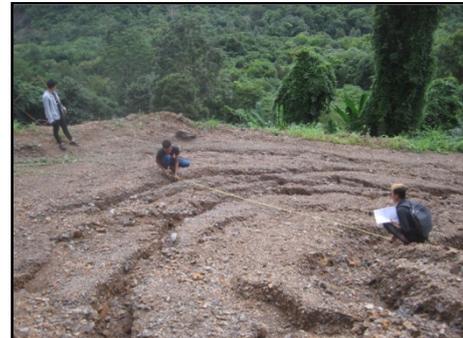
**Figure 15** Creep in cherty limestone of Moulmein Limestone (N16°49' 14.6"E97°41'13.6", Facing - 80°)

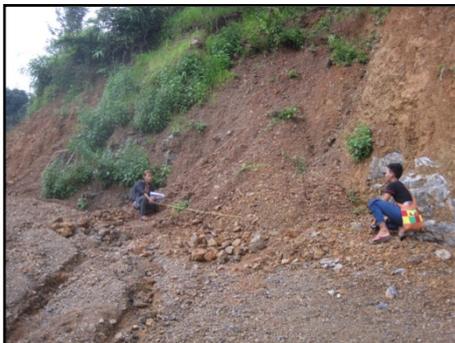
**Figure 16** Rockfall in cherty limestone of Moulmein Limestone (N16°49'14.6"E97° 41'14.3", Facing - 340°)

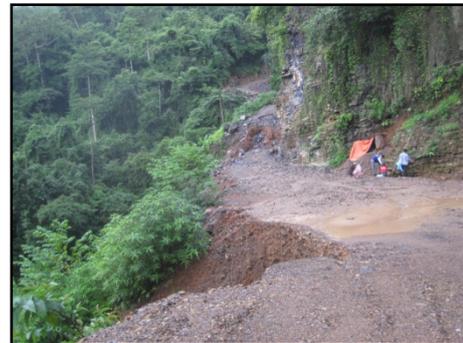
**Figure 17** Debris flow in brecciated limestone of Moulmein Limestone (N16°49'15.4"E97°41'09.6", Facing - 280°)

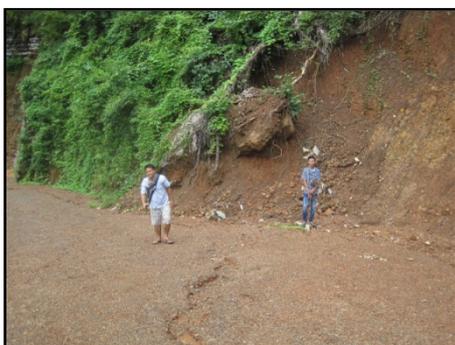
**Figure 18** Rockfall in brecciated limestone of Moulmein Limestone (N16°49'15.4" E97°41'09.6", Facing - 290°)

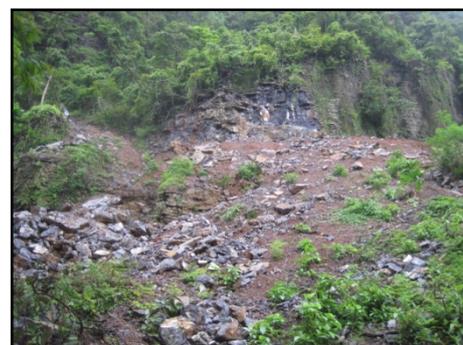
**Figure 19** Debris flow in brecciated limestone of Moulmein Limestone (N16°57'00.2", E97°25'51.0", Facing - 280°)

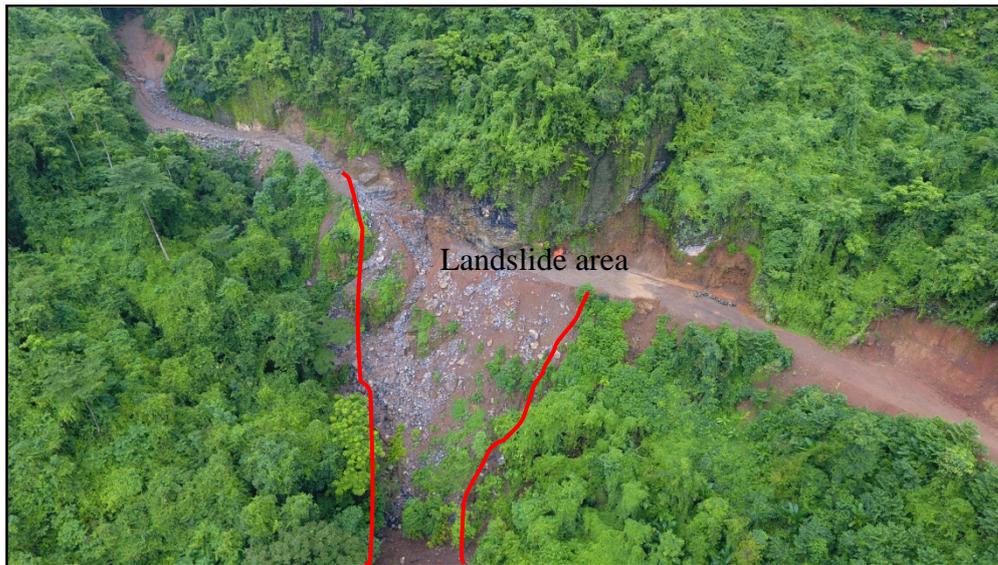
**Figure 20** Big debris flow in the research area (N16°57'00.2", E97°25'51.0")

The big landslide is triggered on 15<sup>th</sup> July, 2018 because of the significant highly rainfall in Kayin State. The width of the landslide scar or debris flow area along the road is 45 meter width and 25 meter length until the base of the mountain. This landslide badly destroyed the road where can't be used in future if the systematic retaining structure and drainage don't use.

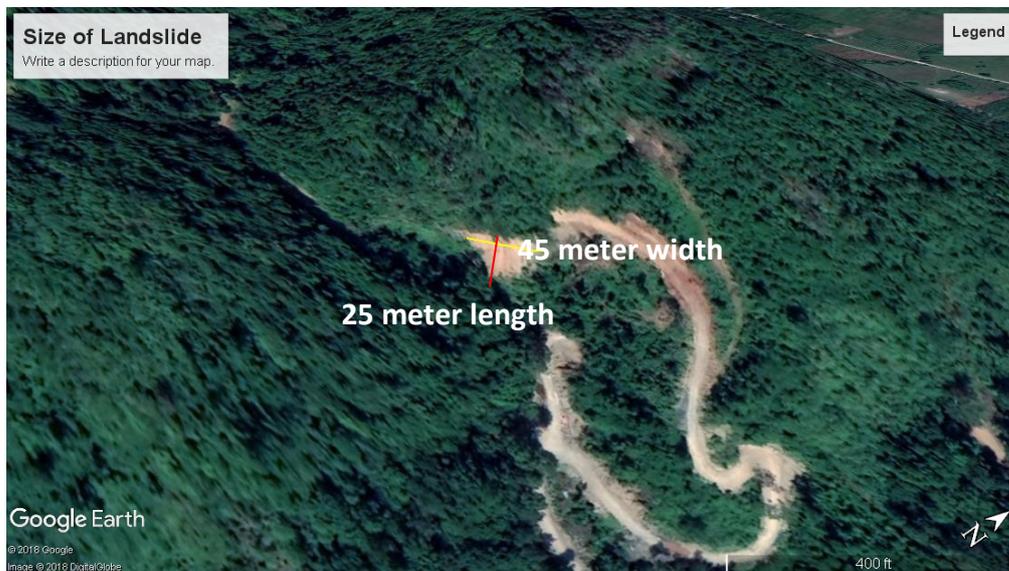
**Figure 21** Size of the debris flow on google map

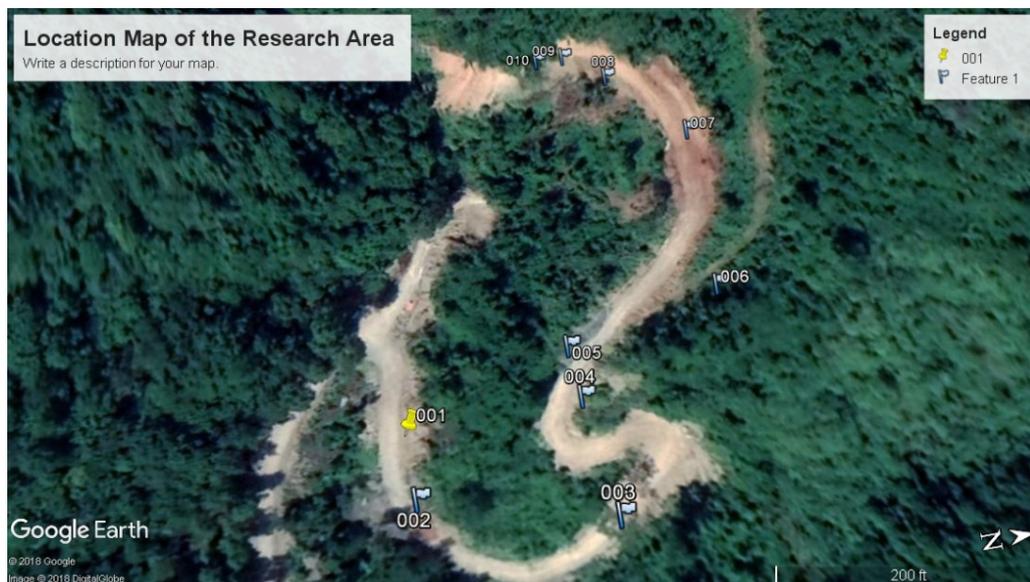
**Figure 23** Slope site localities map of the research area

The volumetric joint count of the area is a measure measured from the joint set spacings within a volume of rock mass and also random joints can be included by assuming a random spacing (Table 2). It is defined as number of joints per m<sup>3</sup>. The slope site localities map is shown in Figure (23).
