CONTAMINATION ASSESSMENT NEAR PUBLIC DUG WELLS ALONG SHWE-TA-CHAUNG CREEK

Public dug wells are commonly used for drinking, bathing, cleaning and cooking purposes. Two water samples from two dug wells, named Yarma and Cow Lake, along Shwe-Ta-Chaung Creek were examined at Public Health Laboratory in two times to determine the contamination of surface associated with waste water. The first time is October 2017 and second time is March 2018. Four water chemical analysis reports for the two wells are chemically unpotable. The results are compared with the World Health Organization (WHO) standard values to identify the existence of contaminants above the acceptable levels. Also four soil samples near each dug well and related creek were determined with Rigaku EDXRF spectrometer in two times to estimate the elemental pollution in the soil. Contamination factor, modified degree of contamination and pollution load index for soil contamination was calculated. The objective of this research is to determine the environmental pollution on the two public dug wells located adjacent to the Shwe-Ta-Chaung Creek in Tanpawaddy Quarter Mandalay, Myanmar. The water supply wells are impacted by contami

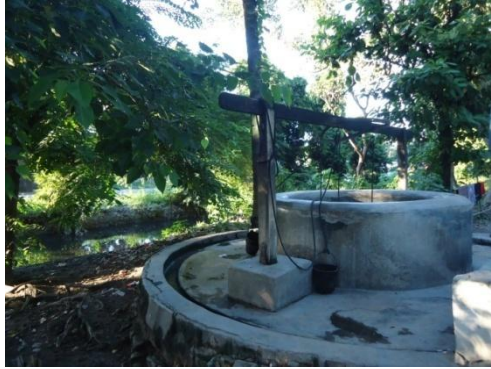
Yarma Dug Well lies at approximately 21° 55' 45" north latitude and 96 ° 4' 4" east longitudes. The well was constructed over 100 years ago. Typically, the well-base is about 30 feet away from Shwe-Ta-Chaung Creek. A garbage area is about 75 feet away from the well-base. The diameter of the well is 6.5 feet and the thickness of the well is 1 foot, which is constructed with a brick lining. The height of the well base is 1.5 feet above the ground. The depth to water from the top of the well casing is 15.35 feet on 12th October 2017. The depth to water from the top of the well casing is 20.5 feet on 5th March 2018. The photograph of Yarma Dug Well beside the Shwe-Ta-Chaung Creek is shown in Figure (1). The width of the creek near Yarma Dug Well is about 25 feet and it lies approximately at 21° 55' 46" north latitude and 96 ° 4' 3" east longitudes. Raw sewage from downtown Mandalay flows into the creek. In this area, the creek is not lined by concrete. Waste water is in direct contact with the ground in the creek. Yarma Dug Well region is located adjacent to the rubbish filter site along the creek. The photograph of trash located near the Yarma Dug Well in the bank of the Shwe-Ta-Chaung Creek is also shown in Figure (2).

Figure 1 Yarma Dug Well beside the Shwe-Ta-Chaung Creek

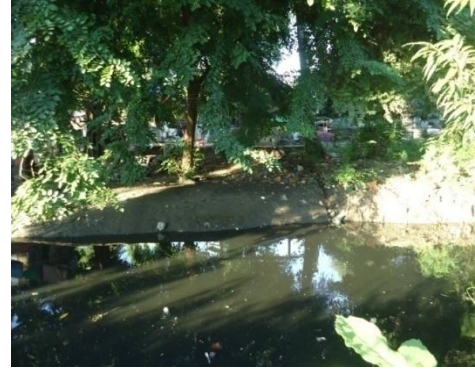
Figure 2 Trash located near the Yarma Dug Well on the bank of the Shwe-Ta-Chaung Creek

According to the results, soil around Yarma Dug Well adjacent to the rubbish filter site along the creek is more polluted than Cow Lake Dug Well region because the distance between Yarma Dug Well is close to the creek than Cow Lake Dug Well. There is more pollution at Yarma Dug Well because there are many trash and garbage near in it.

The waste water creek should be reconstructed with appropriate protection. The creek is too shallow so that it is flooded during the rainy season and the waste water reached to the base of the well. The creek should be constructed with concrete. So the garbage should not be dumped near the well base. Soil around Yarma Dug Well adjacent to the rubbish filter site along Shwe-Ta-Chaung Creek is more polluted than Cow Lake Dug Well region. The pollution around Yarma Dug Well is due to garbage landfills. It is indicated that the water supply wells are impacted by contamination associated with waste water. Humans and animals should not use the wells located near the wastewater creek for any purpose.

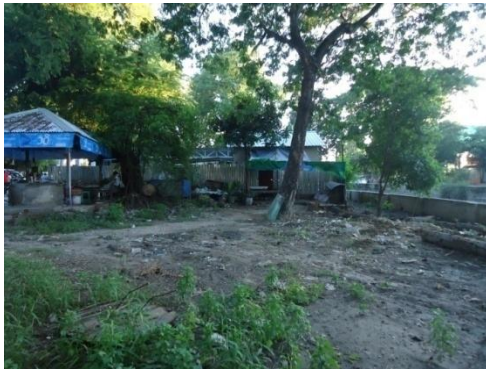
Cow Lake Dug Well lies at approximately 21° 56' 19" north latitude and 96 ° 4' 21" east longitudes. The well was constructed over 100 years ago. Typically, the well-base is about 45 feet away from the creek. A garbage area is about 95 feet away from the well-base. The diameter of the well is 4 feet and the thickness of the well is 11 inches, which is constructed with a brick lining. The height of the well base is 9 inches above the ground. The depth to water from the top of the well casing is 21 feet on 12th October 2017. The depth to water from the top of the well casing is 14 feet on 5th March 2018. The photograph of Cow Lake Dug Well beside the Shwe-Ta-Chaung Creek is shown in Figure (3). The width of the creek near Cow Lake Dug Well is about 20 feet and it lies approximately at 21° 56'18" north latitude and 96° 4' 21" east longitude. Raw sewage from downtown Mandalay flows into the creek. In this area, the creek is lined by concrete. Waste water is not in direct contact with the ground in the creek. The photograph of trash located near Cow Lake Dug Well in the bank of the Shwe-Ta-Chaung Creek is also shown in Figure (4). The photograph of location map of two research sites in Tanpawaddy is represented in Figure (5).

Figure 3 Cow Lake Dug Well beside the Shwe-Ta-Chaung Creek

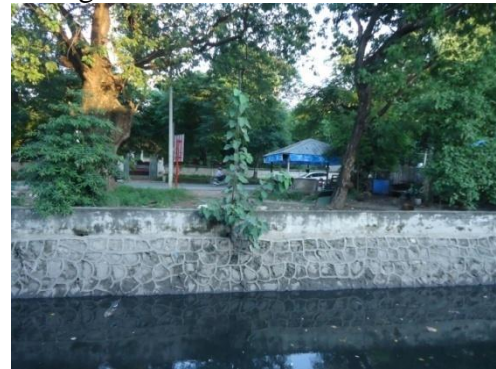
Figure 4 Trash located near Cow Lake Dug Well on the bank of Shwe-Ta-Chaung Creek

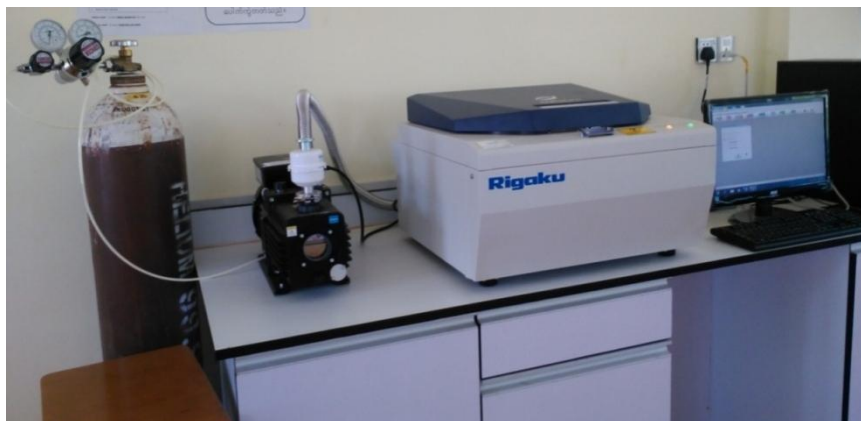
The EDXRF machine (Rigaku) at the University Research Centre, Taunggyi University is used for determination of elemental concentration in the sample of interest in eight soil samples. The photograph of Energy dispersive X-ray fluorescence spectrometer (Rigaku) in University Research Centre, Taunggyi University is shown in Figure (6).

Figure 6 Experimental Set-up for Energy dispersive x-ray fluorescence spectrometer (Rigaku) in University Research Centre, Taunggyi University

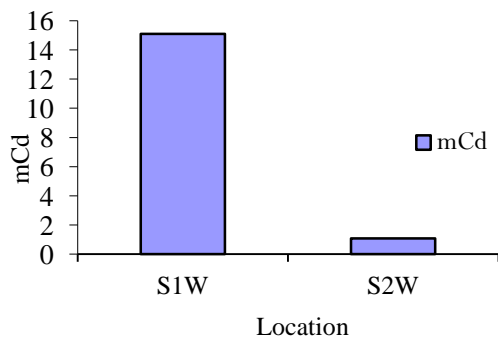
The calculated results of modified degree of contamination (mC_d) for soil near Yarma Dug Well are very high degree of contamination and soil in the bank of the creek near Yarma Dug Well are moderate degree of contamination in the first time. Both modified degree of contamination (mC_d) for soil near Yarma Dug Well and soil in the bank of the creek near Yarma Dug Well are moderate degree of contamination in the second time.

The modified degree of contamination (mC_d) results for soil near Cow Lake Dug Well is very low degree of contamination and the soil in the bank of the creek near Cow Lake Dug Well are moderate degree of contamination in the first time. Both modified degree of contamination (mC_d) for soil near Cow Lake Dug Well and soil in the bank of the creek near Cow Lake Dug Well are very low degree of contamination in the second time.

Figure 7 Comparison of modified degree of contamination (mCd) for soil pollution near Yarma Dug Well and Cow Lake Dug Well in first time

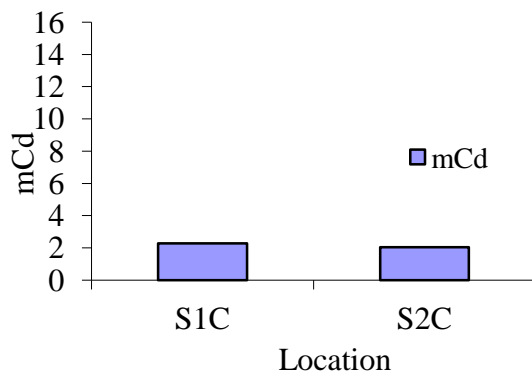
Figure 8 Comparison of modified degree of contamination (mCd) for soil pollution in the bank of Shwe-Ta-Chaung Creek near Yarma Dug Well and Cow Lake Dug Well in first time

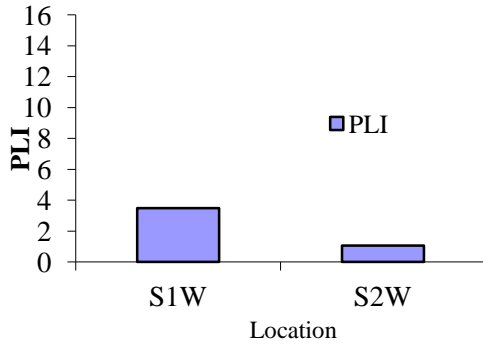
Pollution load index (PLI) for soil near Yarma Dug Well is strongly polluted and for soil in the bank of the creek near Yarma Dug Well is moderately polluted in the first time. Both pollution load indices (PLI) for soil near Cow Lake Dug Well and soil in the bank of the creek near Cow Lake Dug Well are moderately polluted in the first time. Both pollution Load indices (PLI) for soil near the two dug wells and soil in the bank of the creek near the two dug wells are moderately polluted in the second time. The pollution load index (PLI) for soil near Yarma Dug Well would indicate deterioration of site quality. The pollution load index (PLI) for soil near Cow Lake Dug Well presents that only baseline level of pollutants. The pollution load index (PLI) for soil in the bank of the creek near Yarma Dug Well and Cow Lake Dug Well would indicate deterioration of site quality.

Figure 9 Comparison of pollution load index (PLI) for soil pollution near Yarma Dug Well and Cow Lake Dug Well in first time

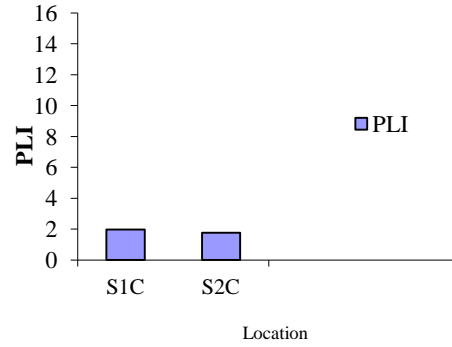
Figure 10 Comparison of pollution load index (PLI) for soil pollution in the bank of Shwe-Ta-Chaung Creek near Yarma Dug Well and Cow Lake Dug Well in in first time

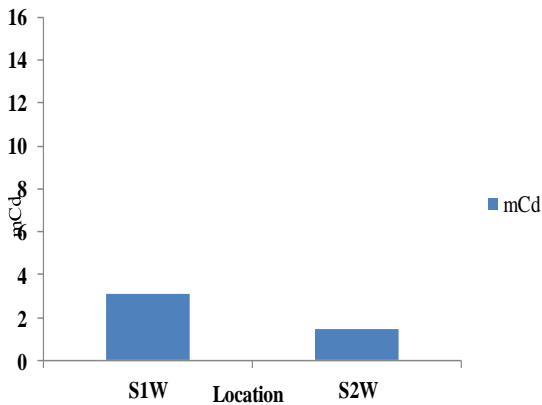
Figure 11 Comparison of modified degree of contamination (mCd) for soil pollution near Yarma Dug Well and Cow Lake Dug Well in second time

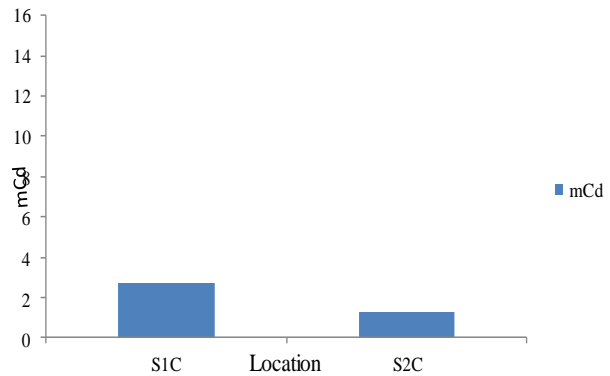
Figure 12 Comparison of modified degree of contamination (mCd) for soil pollution in the bank of Shwe-Ta-Chaung Creek near Yarma Dug Well and Cow Lake Dug Well in second time

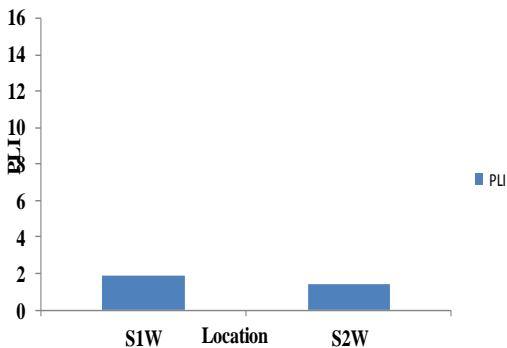
Figure 13 Comparison of pollution load index (PLI) for soil pollution near Yarma Dug Well and Cow Lake Dug Well in second time
