## **ASSESSMENT ON THE STABILITY OF SPILLWAY SLOPE CUTTING AT THE THA-HTAY HYDROPOWER PROJECT, THANDWE TOWNSHIP, RAKHINE STATE**

### **Abstract**

The present research is carried out slope geology, geotechnical characteristics of rocks and slope stability analysis of spillway slope cutting at the Tha-Htay Hydropower Project, Thandwe Township, Rakhine State. This area is tectonically situated at the Central part of the Rakhine Coastal Belt. The rocks comprise the medium to thick bedded, indurated and moderately jointed sandstone intercalated with thinly laminated, fissile, partly carbonaceous shale and mudstone of Ngapali Formation (Middle Eocene). Most of the rock units are trending nearly NW-SE in direction. The fracture system shows as closely spaced and moderately to highly jointed nature in the map of lineament analysis. According to geotechnical investigation, the rocks exposed along the spillway slope cutting site govern fair, poor and very poor rock classes respectively where the rock classes display CL and CM rock classes in this spillway slope site. Therefore, the supporting system should be installed with wire-mesh and rock bolt covering together shotcrete and systematic

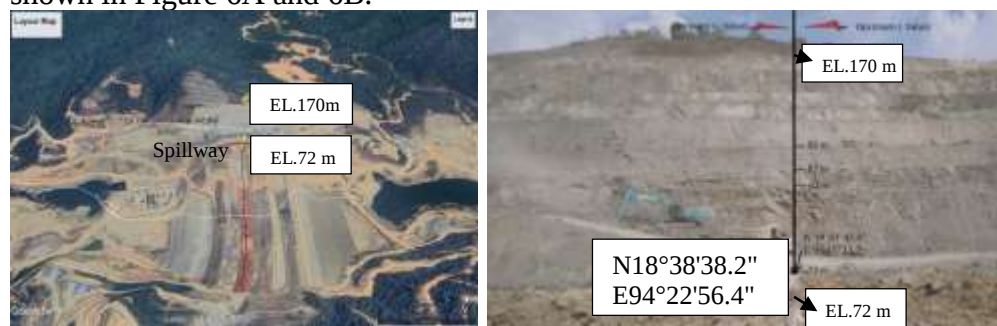
The spillway slope cutting dips to the south with  $160^\circ$ - $180^\circ$  in direction and the general slope inclination is nearly  $60^\circ$  facing to the south. The high of a spillway slope is 170 m which is shown in Figure 6A and 6B.

**Figure 6.** (A) Spillway location on google map (B) layout map of the study slope at the spillway slope cutting

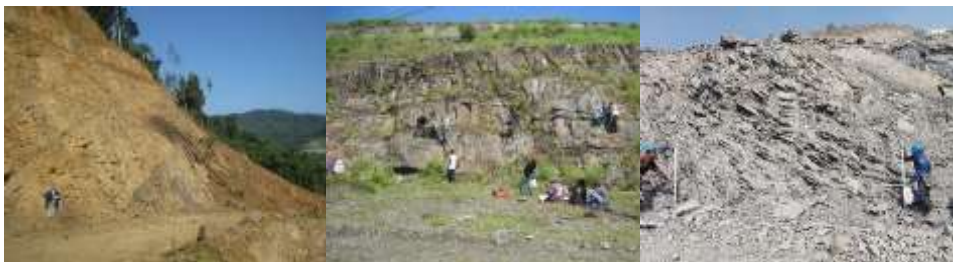
The Ngapali Formation can be divided into three sub-units based on the composition of rock units. Subunit-1 is exposed at the eastern part of the study area and the rocks comprise with light grey to yellowish brown, partly reddish brown, moderately jointed and weathered, thin to medium bedded sandstone intercalated with thinly laminated shale and mudstone which is shown in Figure 7. Subunit-2 is exposed at the Central and South-western parts of the project area and the rocks consist of light grey to grey, partly bluish grey, moderately jointed, thick bedded to massive, turbiditic sandstone intercalated with thinly laminated shale and mudstone which is shown in Figure 8. Subunit-3 is exposed at the Western and Central parts of this area. The rock unit is composed of thinly laminated, dissected, highly friable carbonaceous shale and mudstone interbedded with light grey to grey, thin bedded sandstone which is proved in Figure 9. The geological map is illustrated in Figure 10.

**Figure 7.** Thin to medium bedded sandstone with shale and mudstone at the Upstream

**Figure 8.** Thick bedded to massive sandstone with shale and mudstone at the Dam Axis

**Figure 9.** Thinly laminated, shale and mudstone with sandstone at the downstream
