POTENTIAL LANDSLIDES ON WEATHERED GRANITIC ROCKS ALONG THE MYITKYINA-KANPETII CAR ROAD, KACHIN STATE

Me Me Aung¹

Abstract

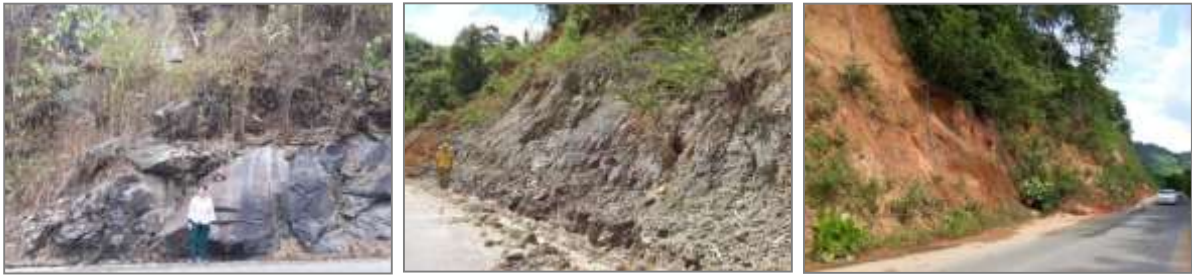
Type-A (without core-stones) contains three characteristic features: (1) fresh rock, (2) decomposed granitoid, and (3) thick layer of residual soil (Fig. 3). Type-A profile is recognized in the field by presence of a very thick layer of residual soil and completely weathered material. Besides, the soil-

rock boundary between the overlain soil material and slightly weathered fresh rocks is very sharp. Some weathering profile can have a thickness of up to 21m (70ft). Both shallow and deep landslides are caused on Type-A profile.

Figure 3 Type-A Profile: (1) fresh rock (N 25° 24' 32.2" and E 97° 58' 01.5"), (2) decomposed granitoid (N 25° 22' 25.2" and E 97° 44' 57.3"), and (3) residual soil (N 25° 23' 46.2" and E 97° 38' 40.5").

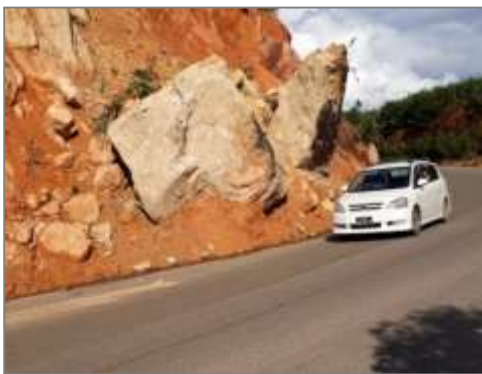
During the stage of **decomposed granitoids**, granular disintegration takes place, and crystals become increasingly detached from each other. At this stage, biotite and feldspar weather first, to form microfractures and pores. The degree of saturation of the decomposed granite is important factor to safety. Saturated decomposed granite has essentially no cohesion when saturation reaches 100%, the apparent cohesion is zero, and pore-water pressures may cause failure. The weathering front in granitoids is abrupt, and water can be perched above the fresh impermeable bedrock. Subsurface water drains through the decomposed granitoid above the fresher rock. Rainstorms usually bring on the failures that produce rockfalls. The most widespread slide problems have been reported at granitoid decomposes stage (Matsuo, 1968; Durgin 1977). Rockfall (Fig.6) and rock slope failure may be occurred on granitoid decomposes areas.

Figure 6 Rockfall site at the side of the road.
(N 25° 21' 35.8" and E 97° 45' 30.1")

Hills with weathered granitoids outcrop having steep slope can cause rockfalls and rock slope failure especially as wedge failure due to its highly jointed nature. To retain the strength of the jointed granitic rocks, rock bolts or anchors should be installed. Besides, forests on hillslope reduce the surface runoff and vegetation cover prevents erosion of the soil slope. The roots of the trees hold on the weathered soil firmly. Trees on hillslope reduce the surface runoff. So planting trees not only reduce the soil erosions but also the dwindling of pore water pressure.

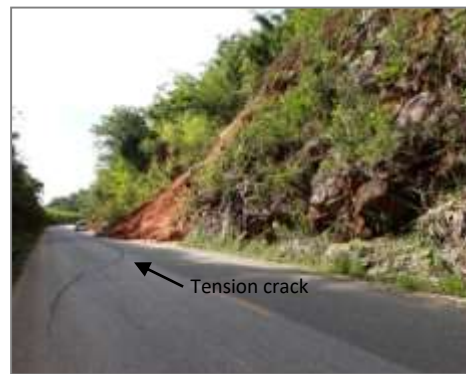
Saprolite is the final stage of weathering results and shows brownish colour overlain by a red lateritic layer. Residual granitoid consists mainly of quartz, muscovite, and kaolinite. Although the presence of overburden pressures, the void ratio increases the pore spaces to decrease as the rock compresses. If tension cracks form at the head of failure plane where the soil will collapse, there is forming a failure (Fig.7). Durgin (1977) described a slope failure characteristic of saprolite is the slump or rotational slide. The rupture surface is no longer controlled by a fresh rock boundary as in earlier stages, but forms a circular failure surface. Rock slope failures especially circular failure may be formed at this stage.

Figure 7 Forming tension cracks indicate to occur circular failure.
(N 25° 21' 35.2" and E 97° 45' 27.1")

Weathered soil, which have been formed by final stage of weathering results, and thick residual soil, may slides as circular failure or plane failure and combination of both. To prevent weathered soil landslide, it need to reduce the overburden weight and to draw out the infiltration water into the soil. So bench cutting the slope or gentle slope may reduce the weight of the soil. To draw out the infiltration water, installation of weep holes should be properly put in. Sometimes construction of retaining walls and installation of the weep holes are more effective to prevent landslides. Good drainage system is needed to prevent infiltration of rain water into the soil and it can reduce the pore water pressure of the soil.

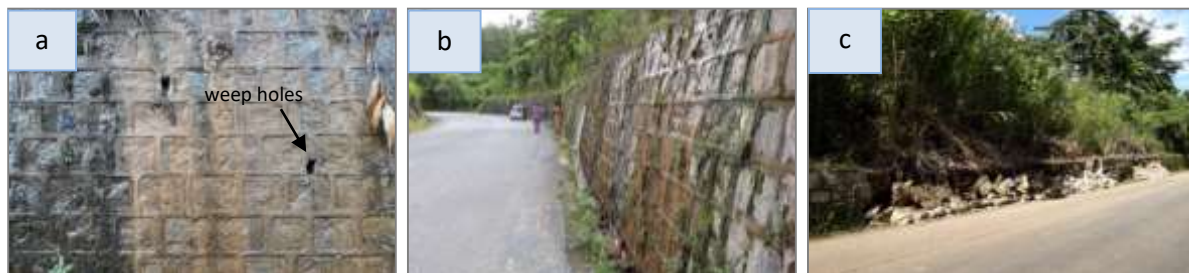
Retaining walls are used to bound soils between two different elevations. Weep holes in retaining walls must be sized adequately to overcome surface tension and they allow water to escape from behind the wall. Although retaining walls have been constructed along the road of the study area, need to repair more effective style, i.e., need adequate size weep holes to drain water. (Fig.9)

Figure 9 Retaining walls, which have been constructed by granitoids, along the Mtitkyina-Kanpetii car road; (a) weep holes (b) wall without weep holes (c) damaged wall.
