GEOHAZARDS AND PRELIMINARY STUDIES ON ENVIRONMENTAL DEGRADATION IN BAGAN - NYAUNG OO AREA, MANDALAY REGION

Abstract

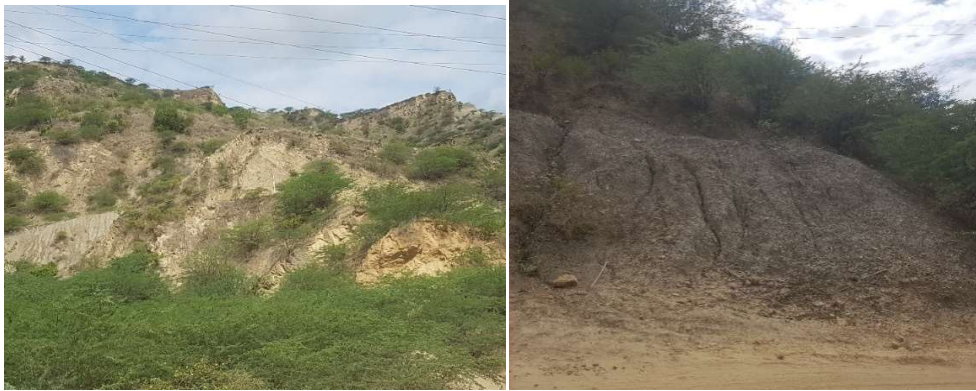
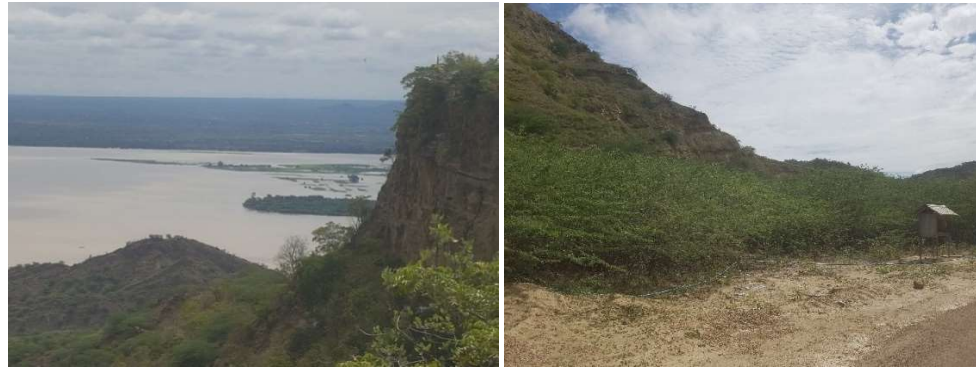
Left = Landslide (Facing- 20°), Right = Old Landslide (Facing- 80°)

Left = Cliff with debris at the bottom (Facing- 70°),
Right = Old Landslide (Facing- 50°),

Figure 10. Landslides in Tantkyi Taung

Active and old landslides are marked in the research area along hill slopes of Tantkyi Taung and Tuywinn Taung Ranges. Small open cracks are denoted on the top parts of the landslides. In these ranges, slope angle of 40°-60° is unstable and can create further sliding in the rainy season. In addition to these, ranges with gully erosion and tension cracks are also recognized. Soil erosion and debris fall are also common on hill slopes of Tantkyi Taung and Tuywinn Taung Ranges because of soft sediments and fast weathering nature, deforestation as well as haphazard exploitation of construction materials. On the eastern flank of Tantkyi Taung Range, debris fall and soil erosion as well as landslides due to steep slopes are observed. High density of joints and differential erosion between soft mudstones and hard sandstones of Tantkyi Taung Ranges are developing to rock blocks which are liable to be detached creating landslide and debris fall hazards.

It is clearly observed on the eastern limb of Tankgyi Taung anticline. Fault trend is running about 346° with steep slope and v-shaped gullies. Along the fault line, scarps are characterized by erosional surface. Figure (9 and 10).

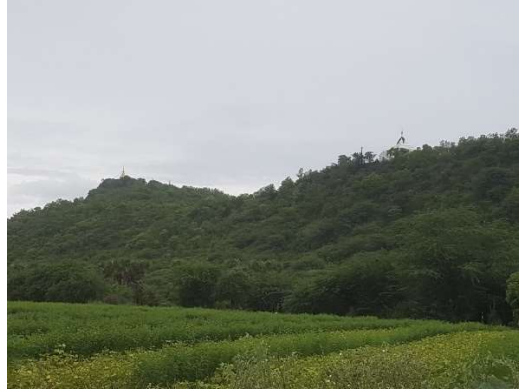
Tuyin Taung (Facing=170°) (N 21 10' 42.4", E 94 52' 31.6")

Figure 11. Landslides in Tuyin Taung

It is clearly observed in TuyinTaung near Bagan. Fault trend is running $N330^\circ$ and fault dips about 46° to the west. Figure (9 and 11).

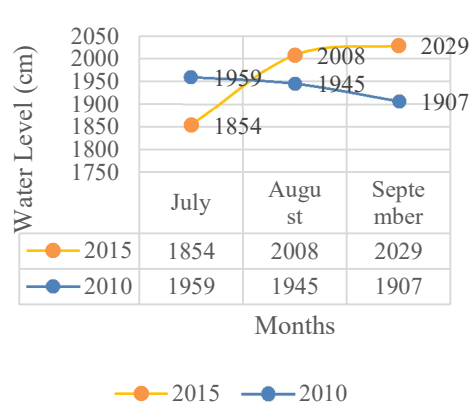
Figure 12. Monthly Mean Water Level of Research Area in 2010 and 2015

In the rainy season, lowlands adjacent to the river and the main streams in the area are likely to be affected by flood as they are prone to flood hazards. Hence, these areas are not suitable for human settlements but can be utilized for agriculture. A risk of flash flood can always be a threat in these areas in future in the rainy season .Figure (12 & 13).

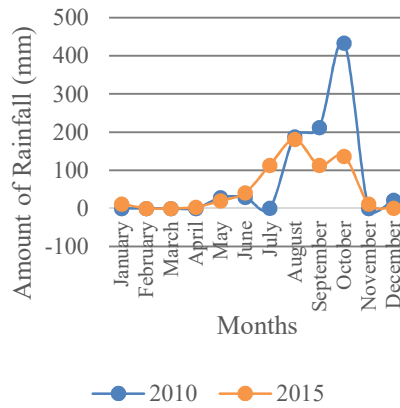
Figure 13. Monthly Rainfall of Research Area in 2010 and 2015

According to the satellite image analysis, the rainfall in 2010 is significantly higher than that in 2015 (Figure 13) (2017 data not available during evaluation) resulting in the difference in volume of water body of Ayeyarwaddy River. In addition to the rainfall, the water level is higher 2015 than in 2010 due to the higher sedimentation of the river, thus sand bars and diluvium from river erosion and flood deposited. (Figure 18, a and b).

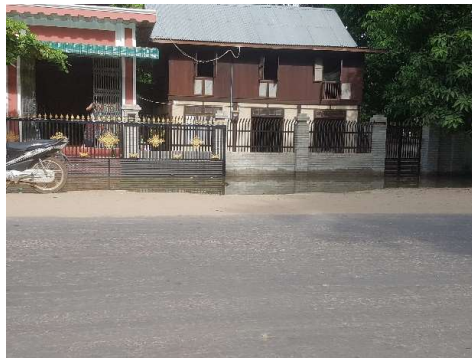
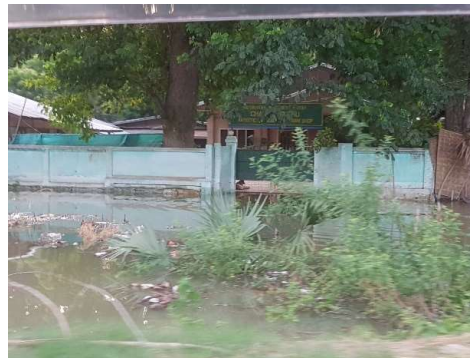
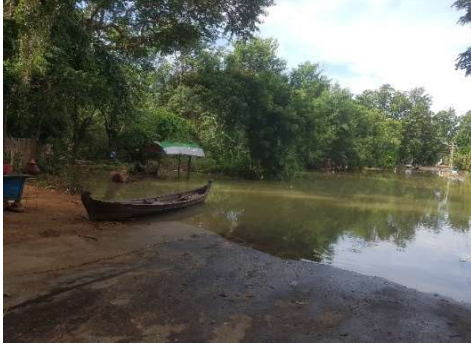
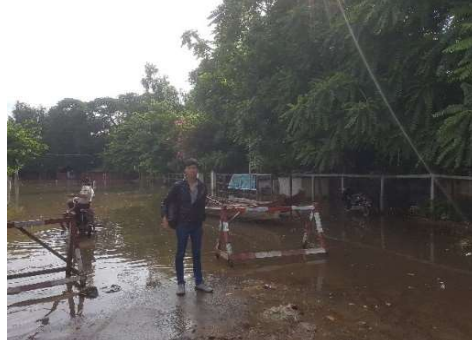
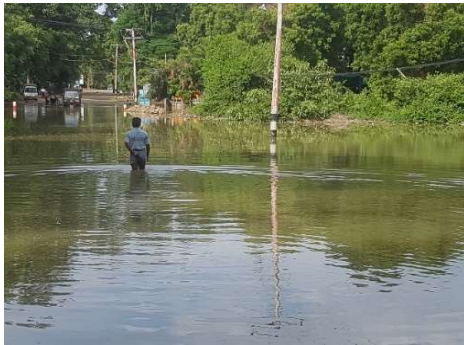
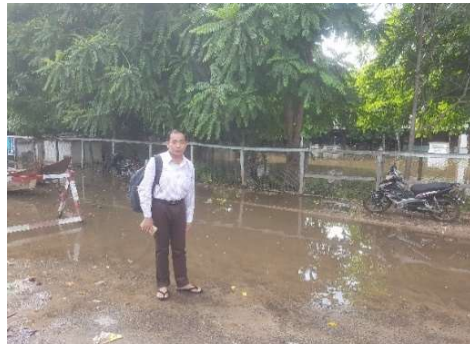
Location -N 21°09'33.6", E 94° 51' 34.5" Flooding in Mingaba village (25th August 2017)

Location: N 21°11'49.1'', E 94°54'9.5' Flooding in Streets in Nyaung-Oo Township (25th August 2017)

Location: N 21 11'13.4'', E 94 53'21.6'' Flooding in Wetkyee Lake (25th August 2017)

Figure 14. (a, b, c & d) Flooding in Nyaung Oo Area

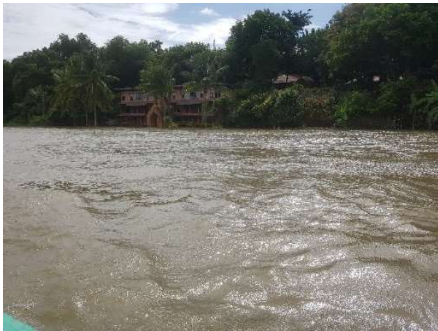
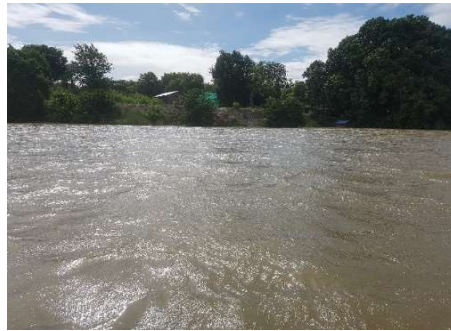
Figure 15. Increase in water level causes river flooding near the eastern bank of Ayeyarwaddy River (25th August 2017)

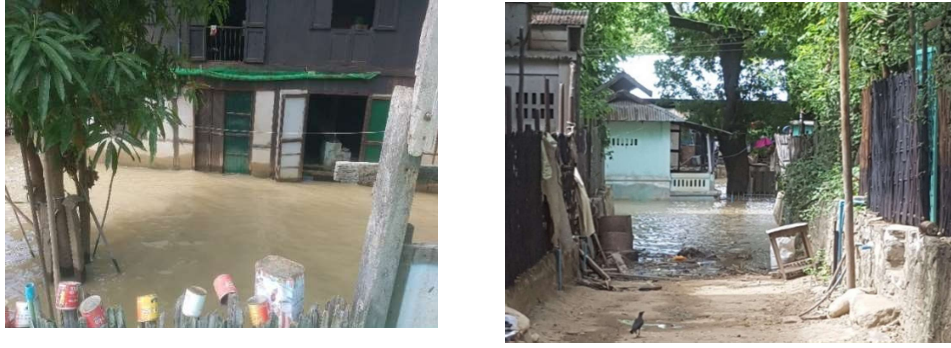
Figure 16. Flooding in Tantkyi village near the west bank of Ayeyarwaddy River (Location: N 21 9' 11.2", E 94 48' 8.9") (25th August 2017)

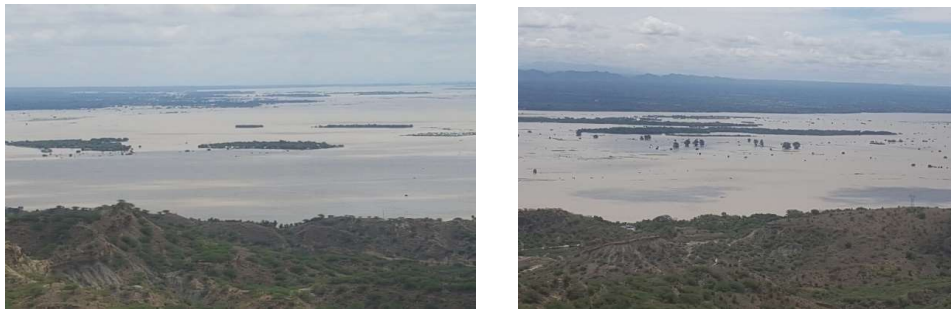
Figure 17. River flooding causes the villages in the central islands to evacuate the Theikkawa villagers to higher ground (25th August 2017)

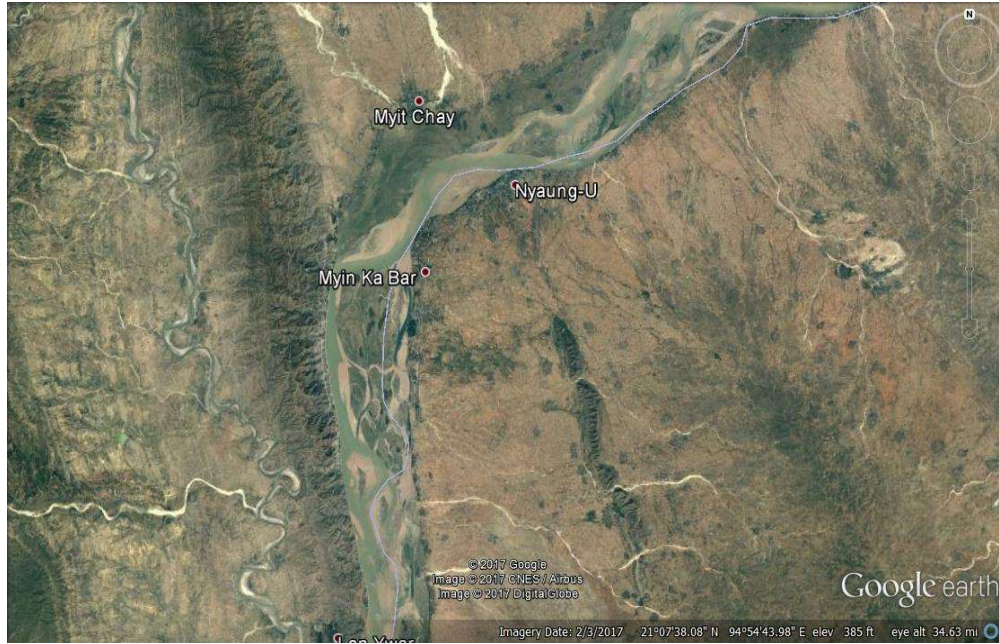
Figure 21. Recent Sedimentation along Ayeyarwaddy River Path Obtained from Google Earth (Imaged in 2nd March 2017)

Sedimentation along Ayeyarwaddy River in March, 2017 as shown in Figure (21) implies that less volume of water body in the river at that time. This indicates that the intensity of flooding will increase during the rainy season.

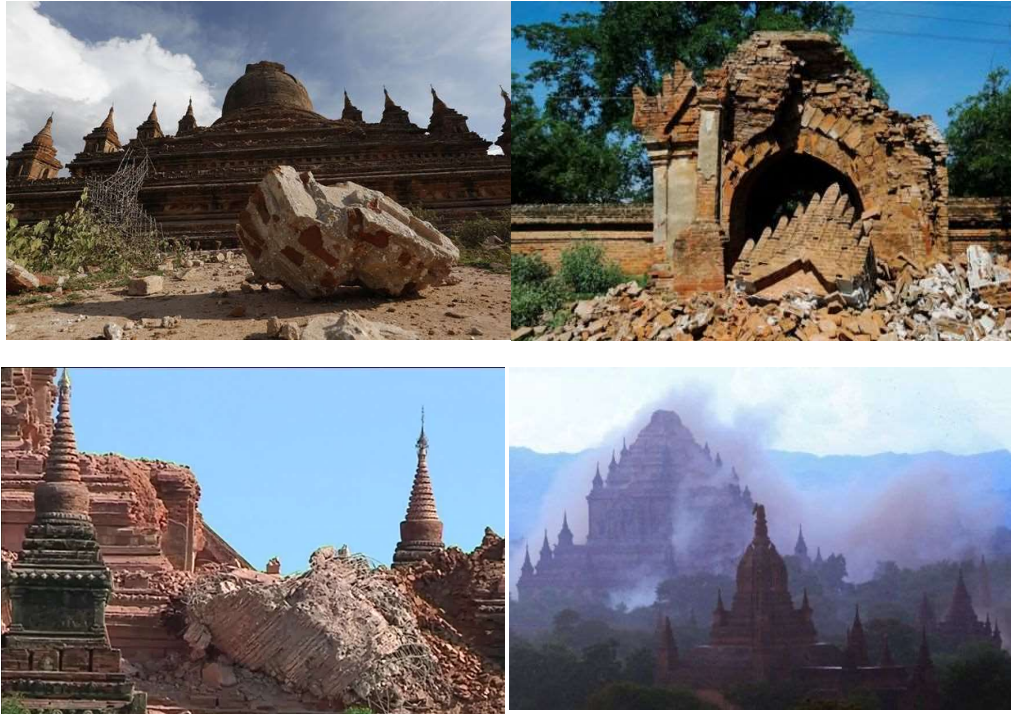
Figure (22, 23, 24, 25) The destruction of Ancient Bagan Temples and Pagodas Caused by (2016 Bagan Earthquake Source: Internet)

The strongest intensity of 2016 Bagan earthquake was felt in Salin, Seikphyu and Chauk which are the most damaged towns and are situated near the intensity level 6. Seismic intensity 5.5 to 6 reached Pakokku, Nyaung Oo, Bagan, west of Kyaukpadaung and Yenanchaung. Due to its effect, many historical structures including monasteries, pagodas, stupas and temples were severely damaged or destroyed. Figure (14, 15, 16 and 17). Statistically, 270 Bagan monuments were destroyed and 3 people died. The buildings around Bagan other than the ancient monuments are also more or less damaged.

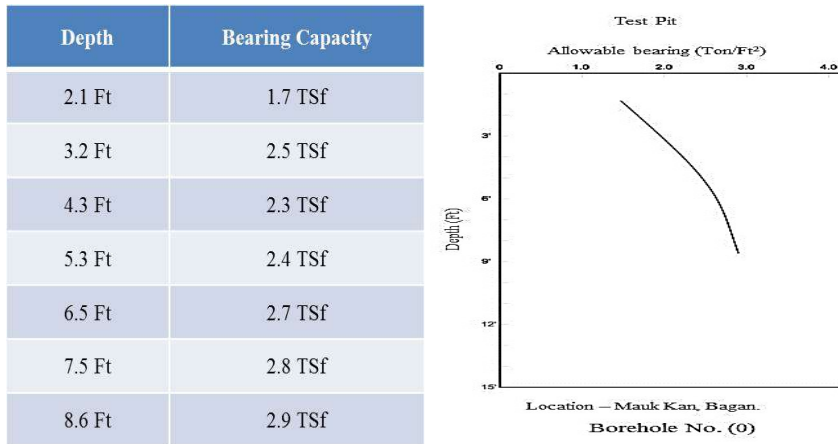
Figure 29. Test Pit Result of Borehole No.(0), Mauk Kan, Bagan

In Bagan area, **residual soil** is developed in place on flat to gentle hill slopes. It mainly consists of clay, silt, and gravel size rock fragments. Mostly, the residual soil in New Bagan is derived from Irrawaddy Formation. Four boreholes data measured by JICA Project and Ministry of Construction are used in engineering analysis for calculation of bearing capacities of each boreholes and test pits. Figure (29, 30, 31).

For Bagan area, since the residual soil comes from Irrawaddy Formation which has a bearing capacity of 2.9 – 4 TSF at the depth of 2m according to geotechnical analysis, shallow foundation with square footing for two to three-storey houses and hotels are suitable for construction. In spite of the availability, the Ministry of Construction stipulates only to build structures of 30ft high with two levels.

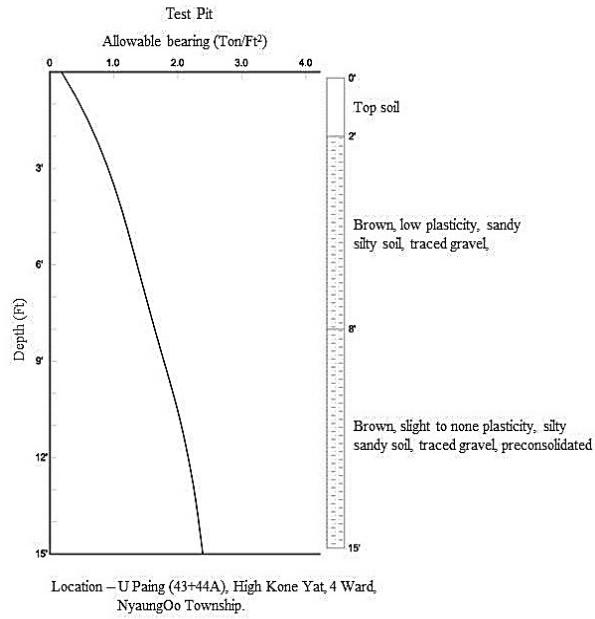
Figure 31. Test Pit Result of Nyaung-Oo Township

We would like to conclude that the bearing capacity of gravel bed in Nyaung-Oo is sufficient for shallow foundation, however, without the compaction of gravel soil under the footing of the specific foundation, It is likely that the differential settlement will occur causing the foundation unstable due to the poorly sorted gravels.

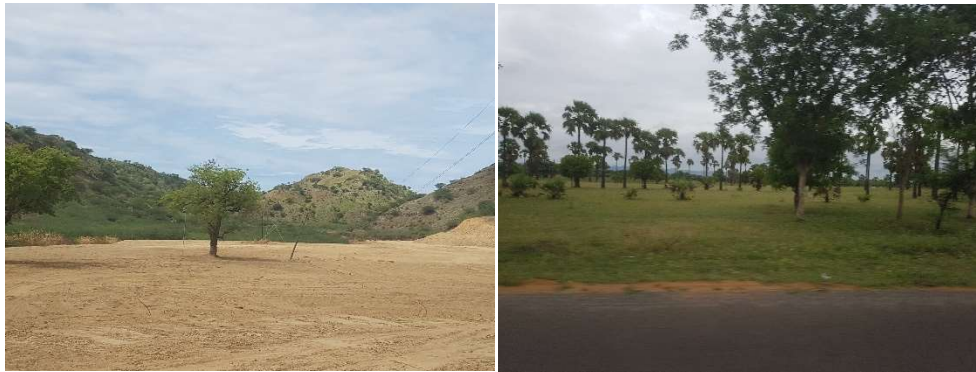
Figure (32, 33) (Left)Urban Settlement and Agricultural and Scrub Land
(Right)

Urban settlements include existing area, planned area, proposed area, and expanded area. Proper drainage system in Nyaung Oo and Bagan is adequate now. Crucial area of man-made pollution is located in the east of NyaungOo. On the banks of the Ayeyarwaddy River, squatters' settlements are creating.

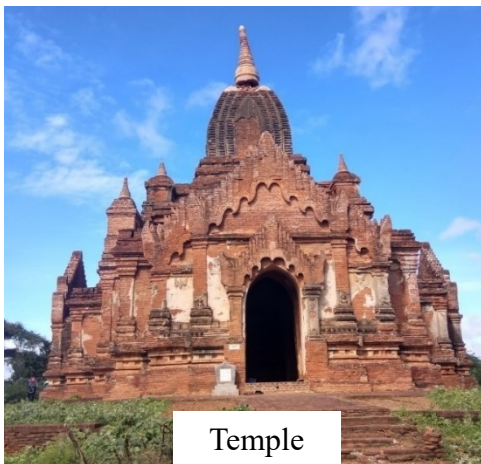
Figure (32) Various Types of Monuments

Bagan has over 3,000 ancient monuments scattered across the vast arid plain. They can be categorized into four types: (1) temple, (2) stupa, (3) monastery and (4) unexcavated mounds. Figure (32) Most of the monuments in Bagan were destroyed by the earthquakes in the past. Table (2) and (3). The repaired parts and upper parts of the monuments (square tower, spire) after 1975 earthquakes were collapsed Figure (33). Vegetation and microorganisms encroaching on the monuments are damaging them. Figure (34). Further studies related with cultural heritage sites and maintenance of monuments are essential for Bagan.

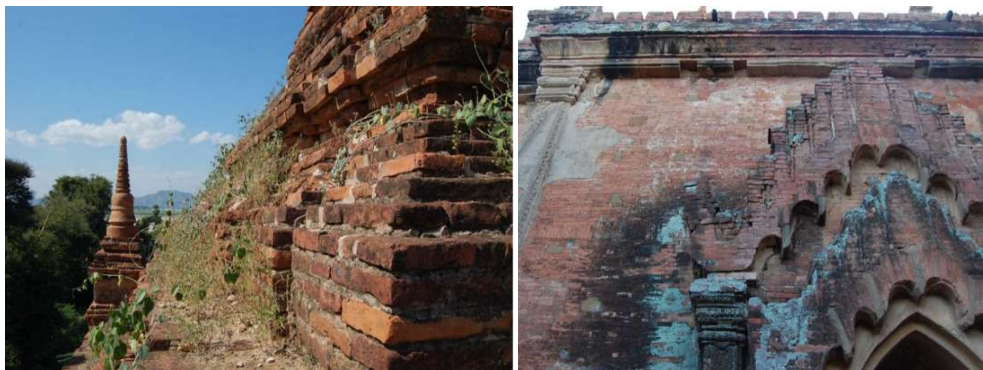
Figure (34) Damages Due to Vegetation and Microorganism
